# Hands On Learning

### ROMAN BUILDINGS

AH 28

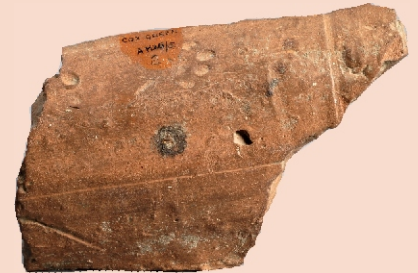
### Roof Tile Fragment

The Romans introduced several forms of tile into Britain. In Calleva Atrebatum (Silchester) some buildings were roofed with overlapping diamond shaped stones. The more well-known system involved two quite differently shaped roof tiles - tegulae (singular is tegula), which were flat oblong tiles with raised sides, and imbrices (singular is imbrex), which are like clay pipes sliced in half and slightly enlarged at one end. They fit together so that a tegula always slightly overlaps the one below it and on each side the gaps between the tegulae are covered by the imbrices. This is very similar to tiled roof construction still in use in many parts of the world today.

A full roof made of them must often have been very heavy and would have needed a strong and well-maintained system of rafters to support them. The tile in this box is an imbrex. Paw-prints of a cat can be seen impressed on it. Dogs tend to leave noticeable claw prints, whereas cats retract their claw while walking - there are no claw prints here. Animal prints like this are quite common, suggesting that a large population of dogs and cats wandered freely around Roman settlements.

This tile is from the Roman villa at Cox Green, on the edge of Maidenhead, which began life in the second century and lasted until the end of the fourth. Like most such country houses it followed the classic corridor pattern - a row of rooms with a corridor running along the front. In the late second century a hypocaust and bathing suite were added to the building.

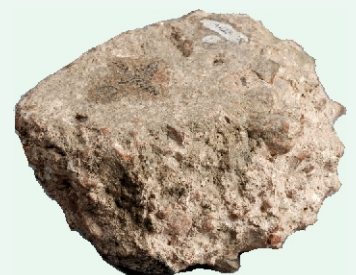
### Fragment of Opus Signinum

Opus signinum is a type of Roman flooring. In Britain it usually consisted of lime mixed with crushed brick or tile. Small pieces of tile/brick can be seen in this sample. Opus signinum could be used to create a simple but strong floor surface, or on walls, or to waterproof baths. This sample also comes from the villa at Cox Green.

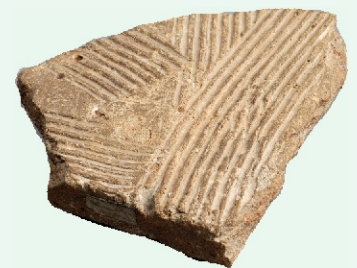
### Patterned Tiles

Both of these examples are fragments of box flue tiles. Such tiles (tubuli) lined the walls of rooms which had under-floor heating. Shaped rather like cereal packets with their ends knocked out, they were stacked one above the other, forming a hollow pipe, through which warm air, heated in the hypocaust, could flow up the walls and the gasses exit at the top. Flue tiles had to be secured to the walls or to their neighbours. To help the plaster gain a grip they were impressed with patterns usually made with a 'tile comb', rather like a fork with sharp teeth.

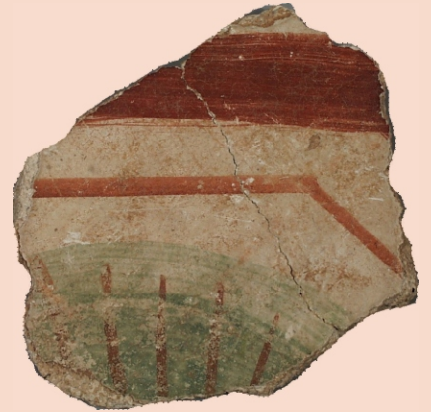
### Fragment of Coloured Wall Plaster

Most Roman-style buildings, even houses with few pretensions, would have had plastered walls. Those who could afford would pay for the walls to be painted with designs often in rooms with mosaic floors. The large wall paintings that have survived at Pompeii, in Italy, show how sophisticated these paintings could be. Extensive sections of painted walls have survived in Britain at Verulamium (St Albans), Portus Dubris (Dover) and elsewhere. Some of it is finely done, producing 3-D effects, but most fragments imply simpler design schemes than those found in Italy. Fragments that have survived from Calleva Atrebatum (Silchester) show leaves and flowers. The colours used include green and a brick-red, as in this example, which seem to have been very popular.
